The purpose of this Memo is to present the preliminary results and mitigation associated with the hydraulic analysis of Ash Canyon Creek in support of the FEMA Conditional Letter of Map Revision (CLOMR) to be submitted in association of the proposed Andersen Ranch West development. The proposed development is located within a Zone AE flood zone without a regulatory floodway, which includes Base Flood Elevations (BFEs) that have been determined by detailed methods, as shown on the effective FEMA Flood Insurance Rate Map (FIRM) panel #3200010091F, dated 2/19/2014. Additionally, a LOMR (20-09-0437P) that includes the Andersen Ranch West parcel was completed by House Moran and became effective 2/18/2021. The LOMR revised the existing conditions FEMA model and mapping. The site boundary and effective FEMA mapping are illustrated on Figure 1 below.

Andersen Ranch Development  
(AKA The Vintage at King's Canyon)  
**VICINITY MAP**

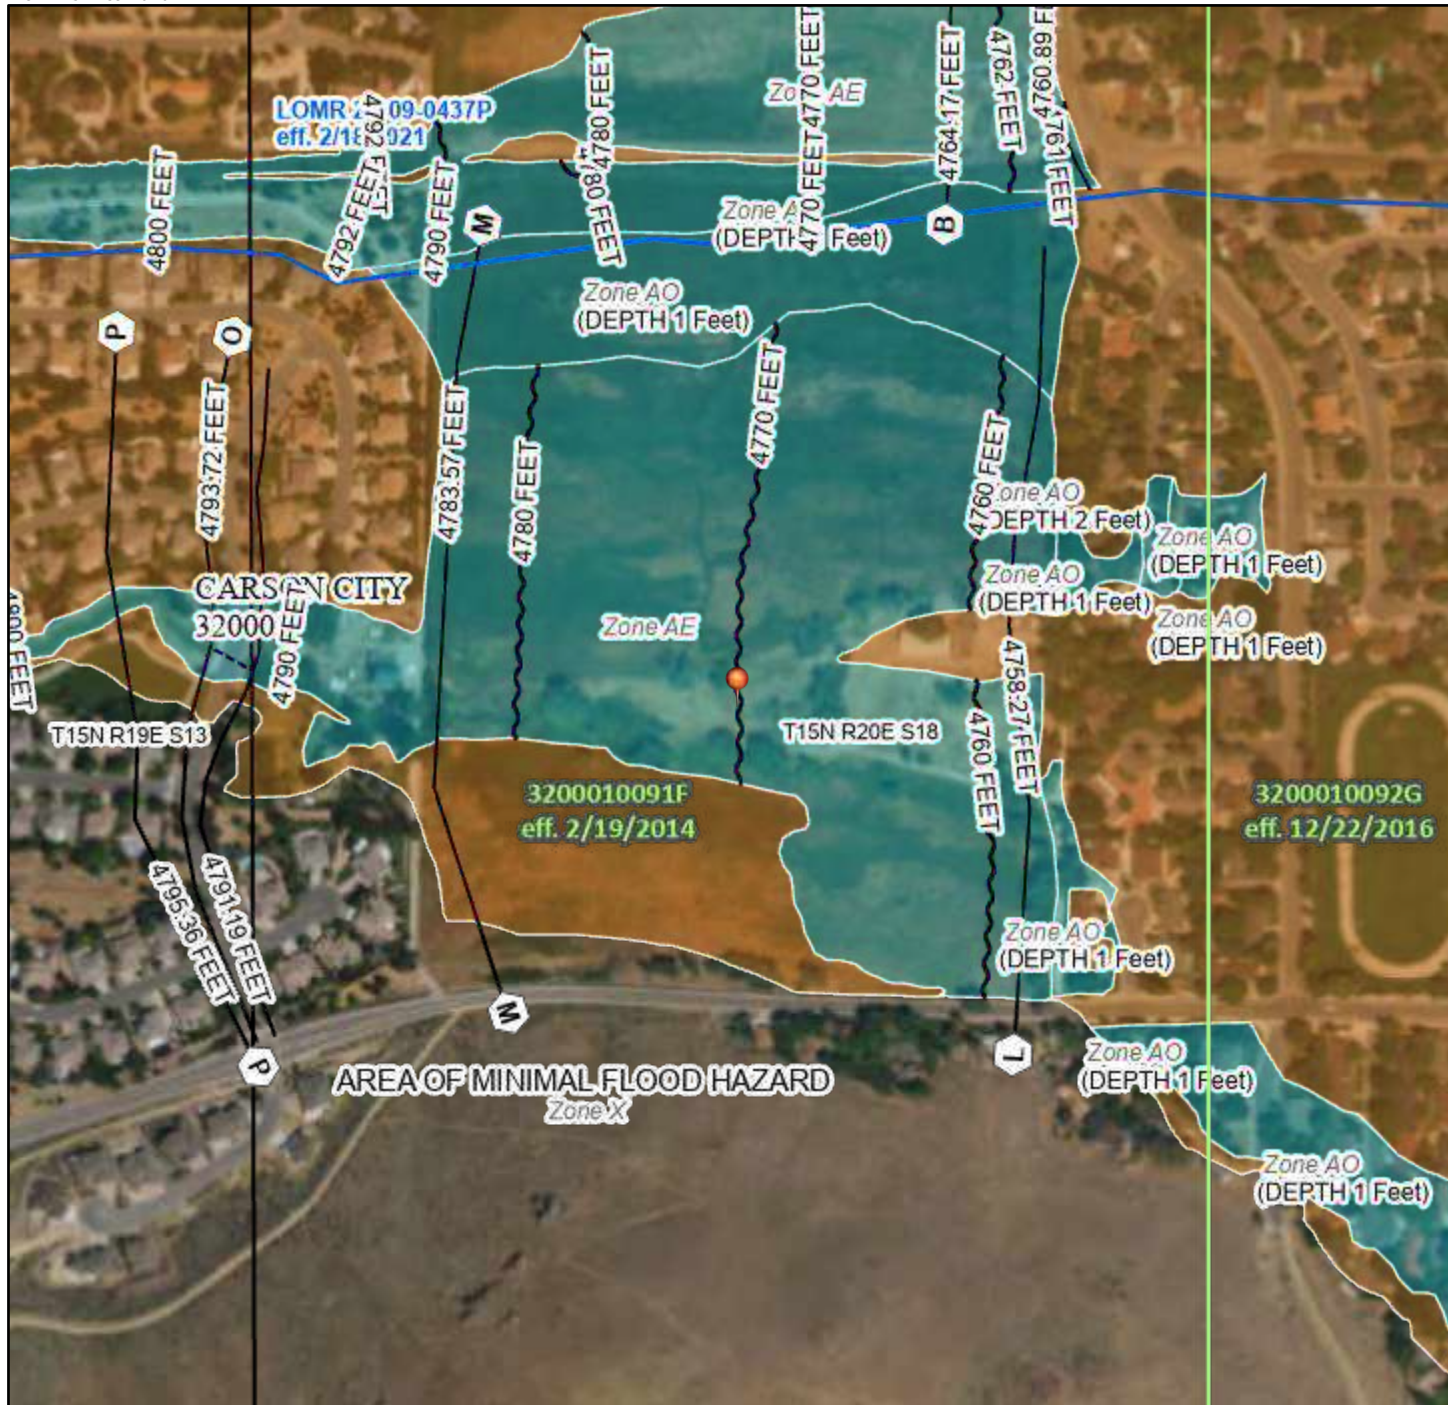
The flood hazard information is derived directly from the authoritative NFHL web services provided by FEMA. This map was exported on 8/2/2022 at 12:26 PM and does not reflect changes or amendments subsequent to this date and time. The NFHL and effective information may change or become superseded by new data over time.

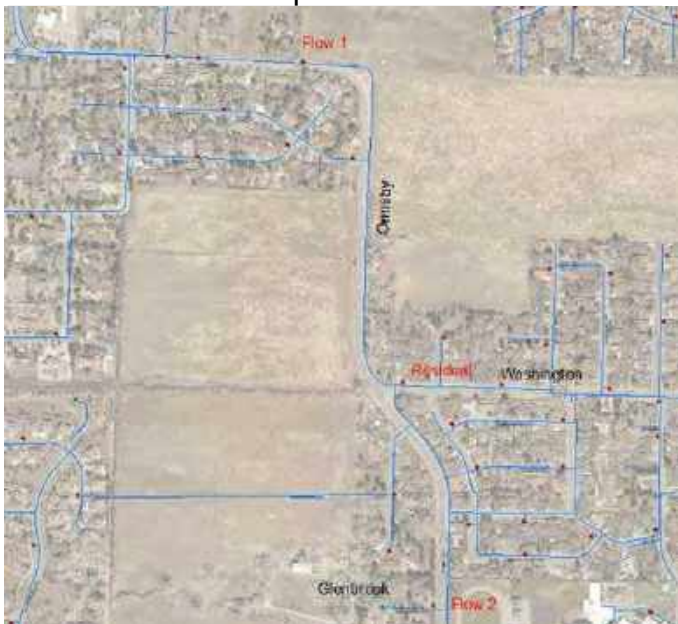
Area Map

Residual Hydrant		Flow Hydrant(s)					
Static:	78 psi		Testing Apparatus	Pitot Pressure (psi)	Discharge Diameter (in)	Outlet Coeff. (c)	Pitot Flow (gpm)
Residual:	72 psi						
Pressure Drop:	6 psi	Flow 1	HM2	26	2	1.307	795
	8 %	Flow 2	HM1	17	2	1.307	643
		Flow 3					
Total							1439

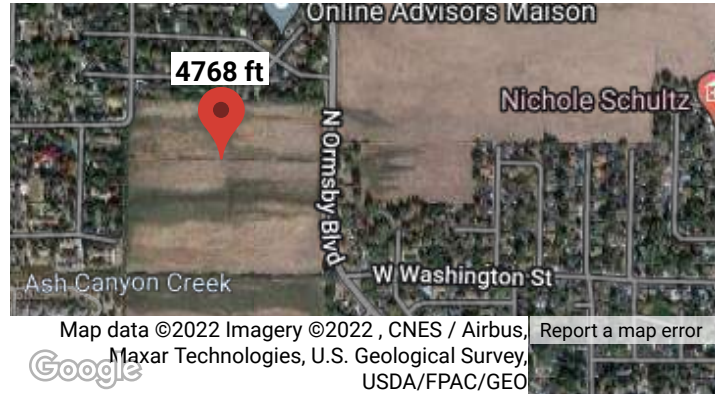
**Coordinates:** 39.170525, -119.784665  
**Elevation:** 4768 ft  
**Timestamp:** 2022-07-05T15:15:46.882Z  
**Hazard Type:** Seismic  
**Reference Document:** ASCE7-16  
**Risk Category:** II  
**Site Class:** D-default

Name	Value	Description
S <sub>S</sub>	2.143	MCE <sub>R</sub> ground motion (period=0.2s)
S <sub>1</sub>	0.785	MCE <sub>R</sub> ground motion (period=1.0s)
S <sub>MS</sub>	2.572	Site-modified spectral acceleration value
S <sub>M1</sub>	* null	Site-modified spectral acceleration value
S <sub>DS</sub>	1.714	Numeric seismic design value at 0.2s SA
S <sub>D1</sub>	* null	Numeric seismic design value at 1.0s SA

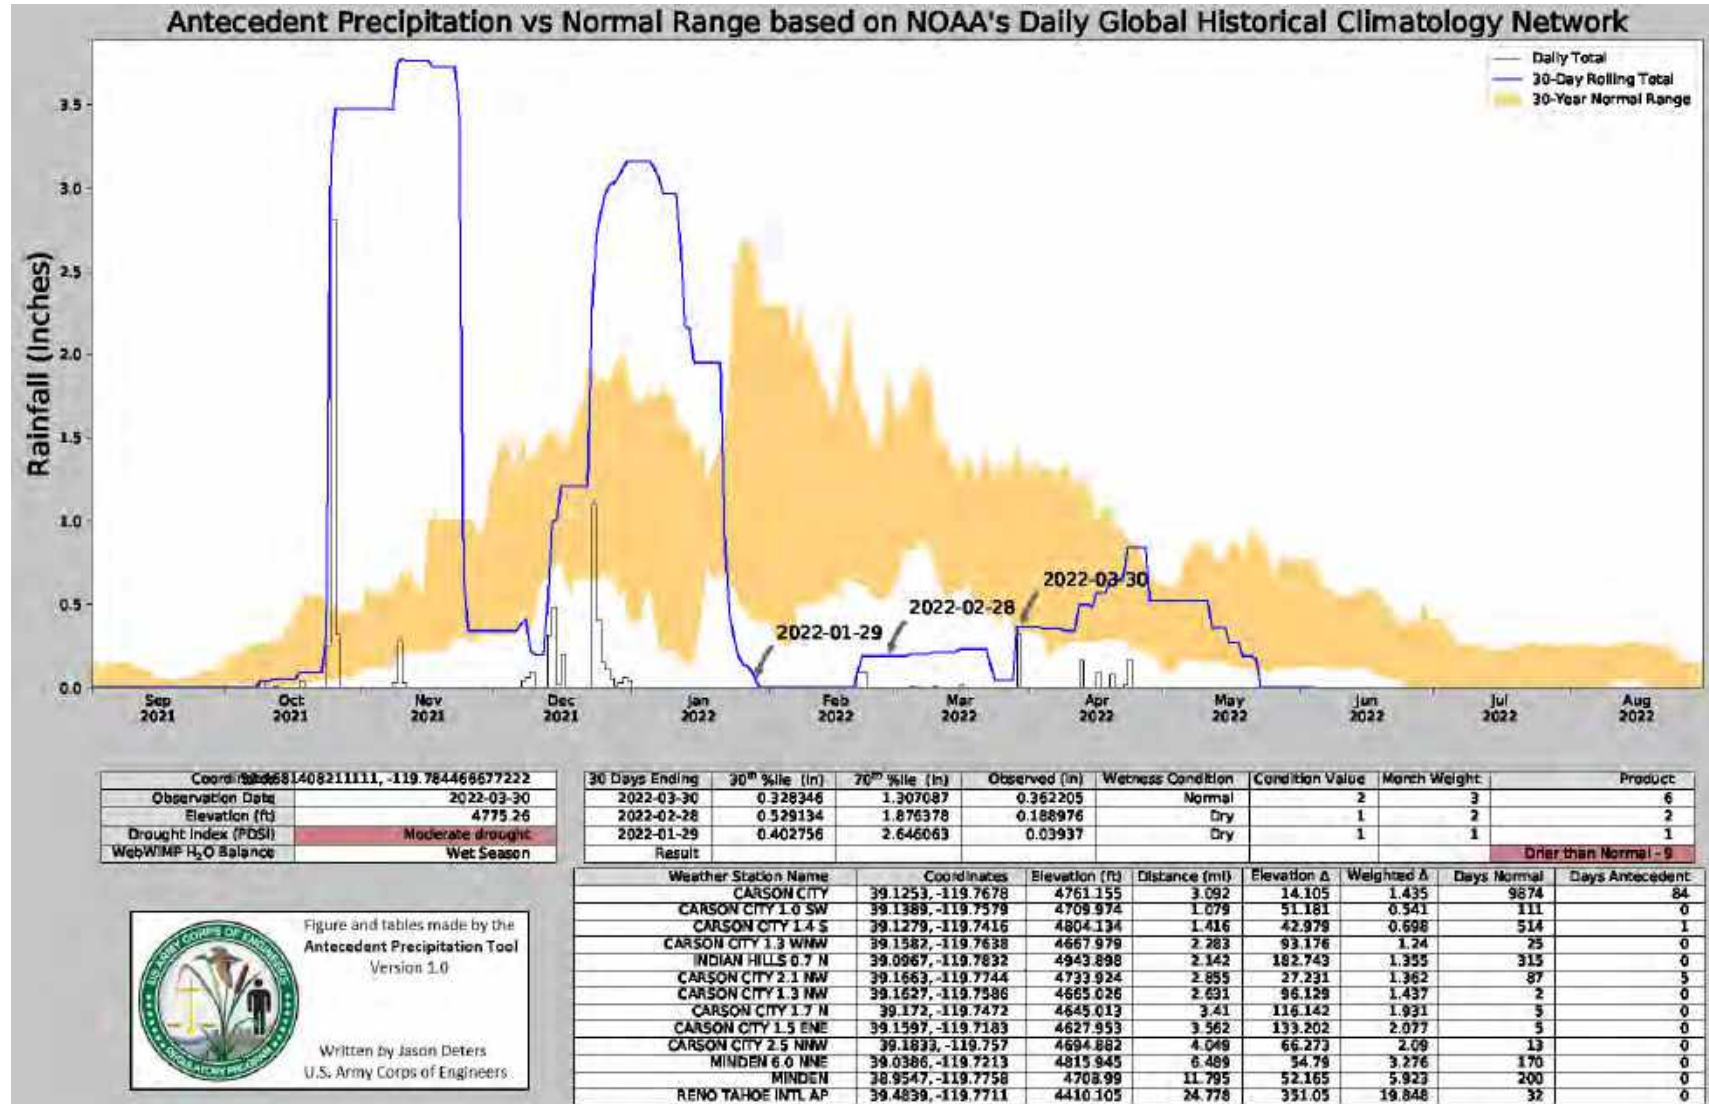
Graph 1. Antecedent Precipitation vs Normal Range Precipitation Graph

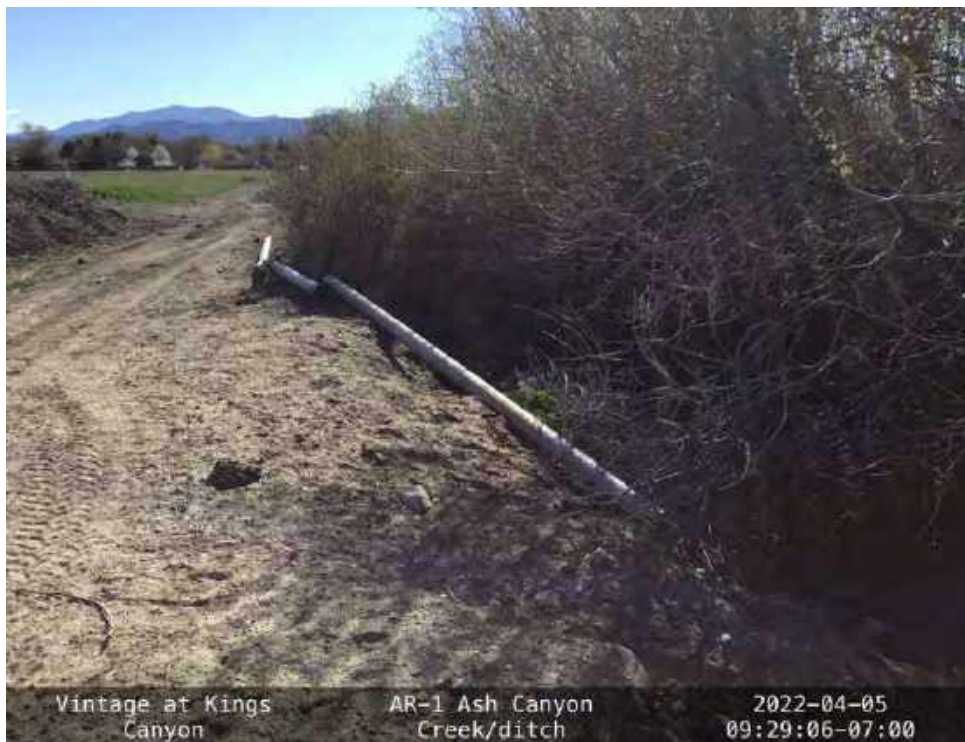
Photo 4. Overview of Ash Canyon Creek (AR-1). View looking east on north bank.

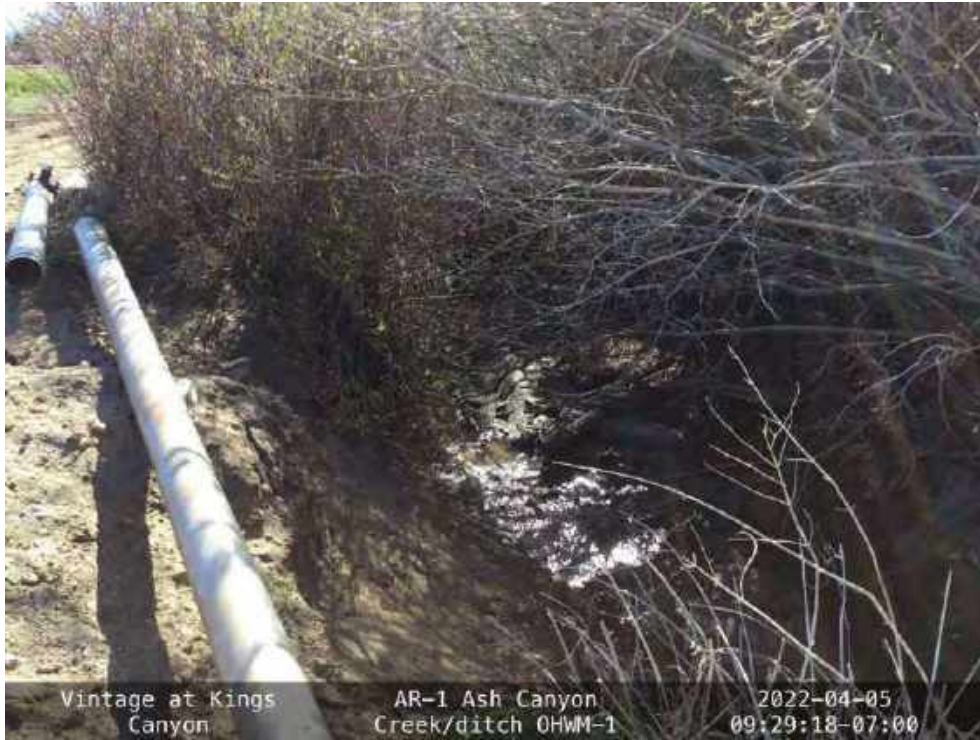
Photo 5. OHWM-1: picture showing approximately 2-4 inches of water in Ash Canyon Creek (AR-1). Exposed/partially excavated left bank with disconnected irrigation line. View looking southeast.

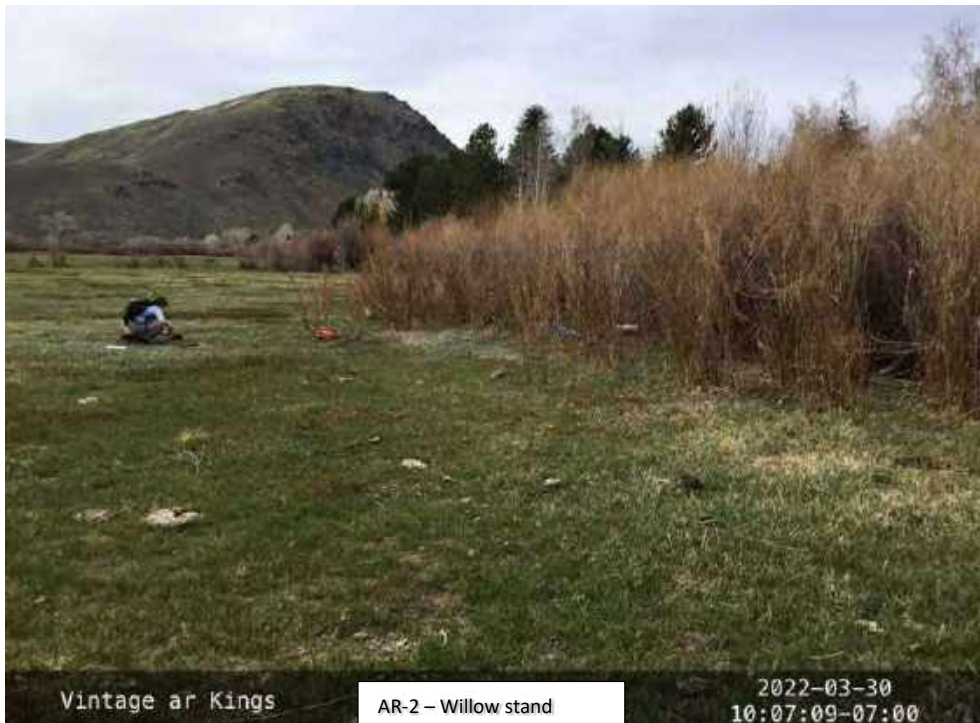
Photo 6. AR-2: Irrigation ditch running along the western boundary of Survey Area, flows south to north then terminates at northwest corner. Water from AR-2 flood irrigates pasture visible in picture. View looking south.

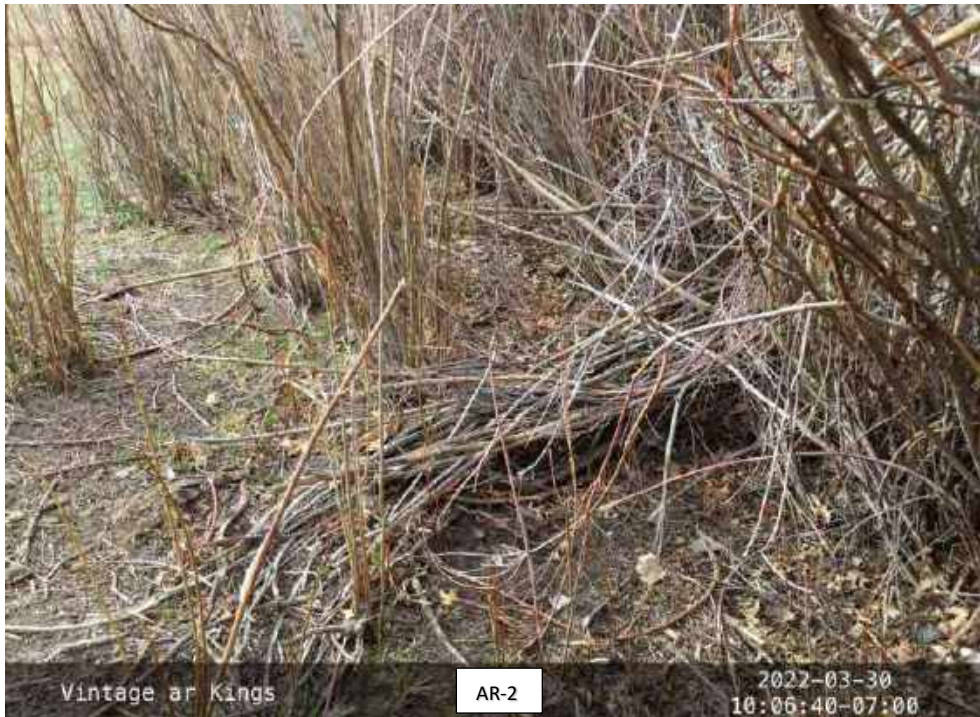
Photo 7. OHWM-2: AR-2 irrigation ditch at western boundary of Survey Area. Thick willow obscuring view of channel. Average channel width approximately 5 feet. View looking southwest.

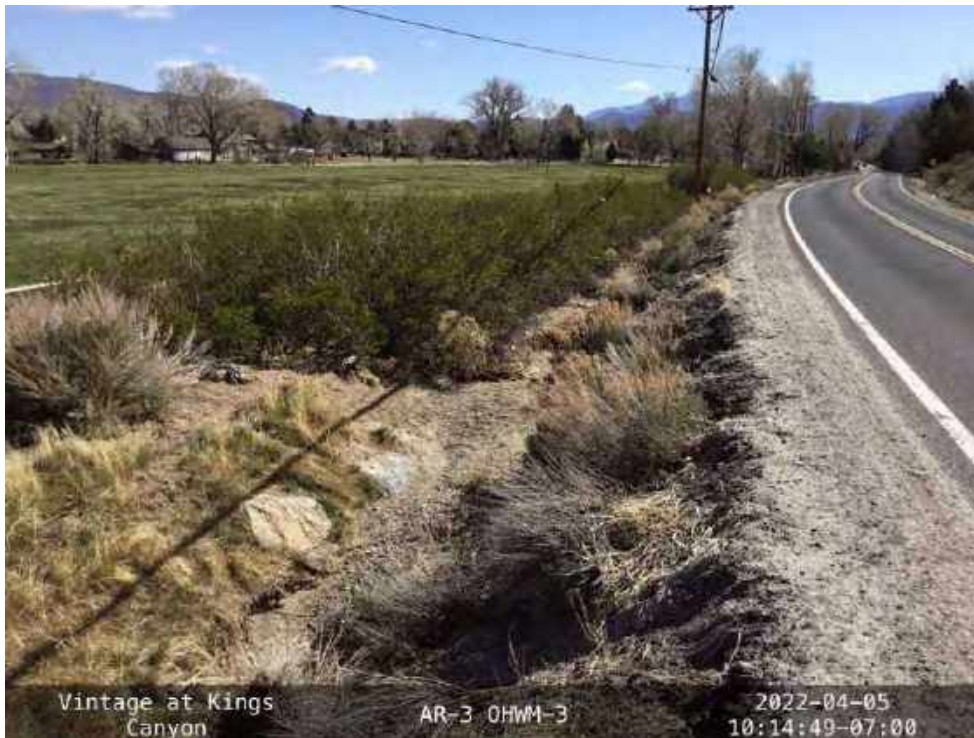
Photo 8. OHWM-3: AR-3 excavated roadside ditch capturing storm water from road. When present, water flow from west to east into storm drain at southeast corner of Survey Area. View looking east.

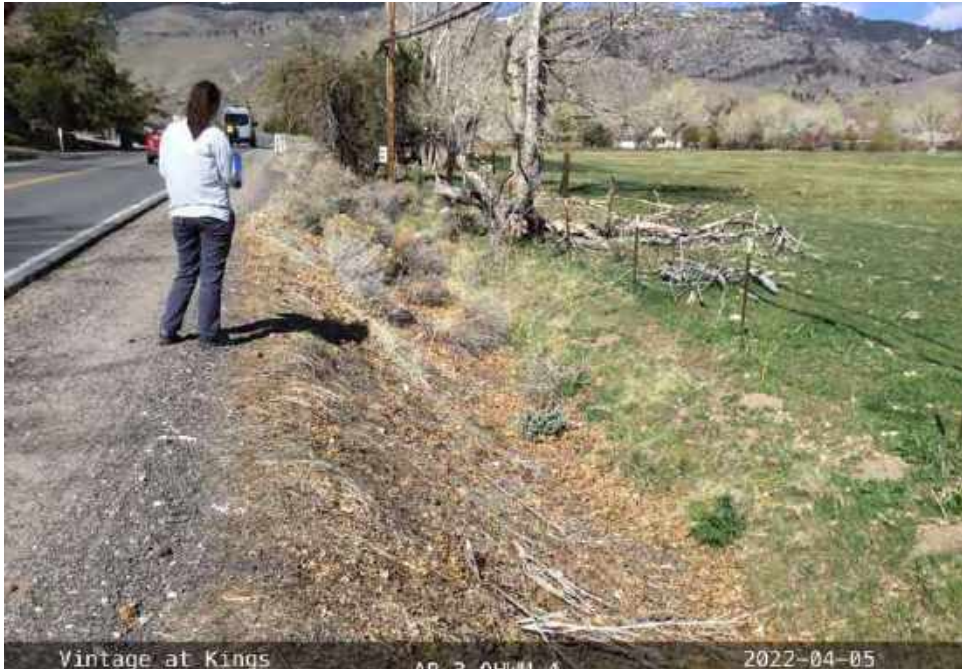
Photo 9. OHWM-4: AR-3 excavated roadside ditch at eastern end when some overland flow from irrigated pasture may intermittently be entering ditch. View looking west.

The on-site length of AR-3 is 1,350 feet (0.03 acres), with an average width of one foot at the OHWM. The OHWM was identified in the field by a lack of vegetation, change in substrate, and a scour line. AR-3 is described in OHWM-3 and OHWM-4 located in Attachment F and shown in photos 8 through 10 in Attachment C.

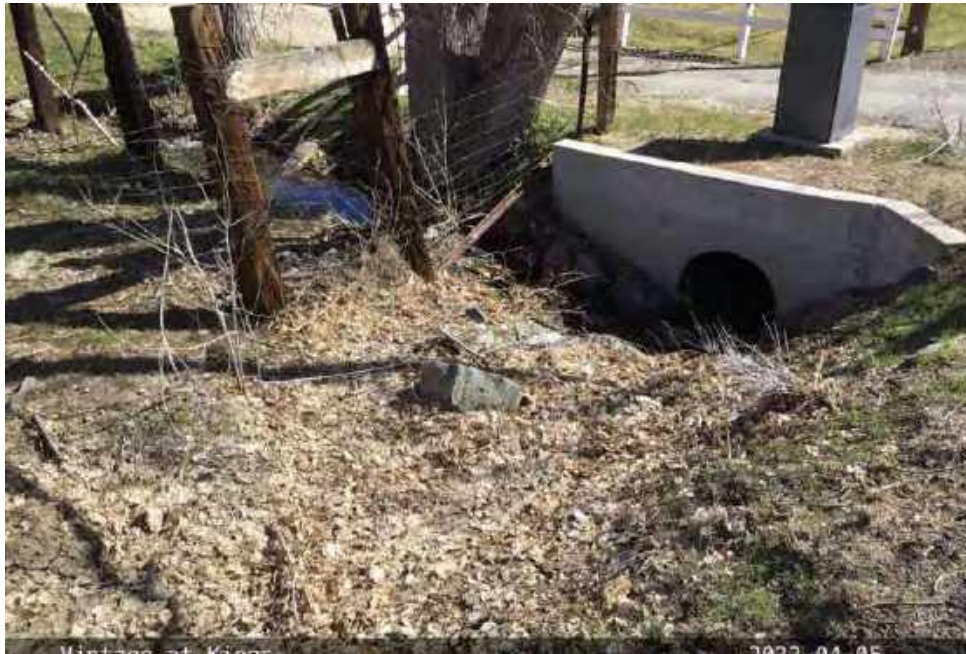
Photo 10. AR-3 at southeast corner of Survey Area where waters, when present, exit off-site into storm drain. View looking northeast.

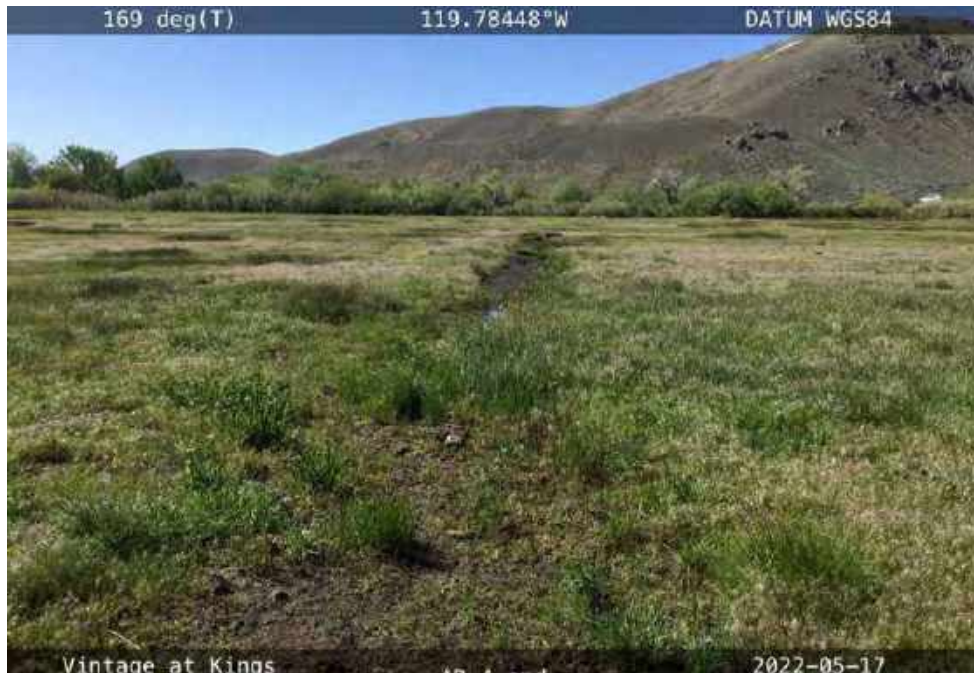
Photo 11. AR-4b: Older excavated irrigation ditch no longer conveying water, only capturing sheet flow from northwestern half of pasture when irrigated. View looking south.

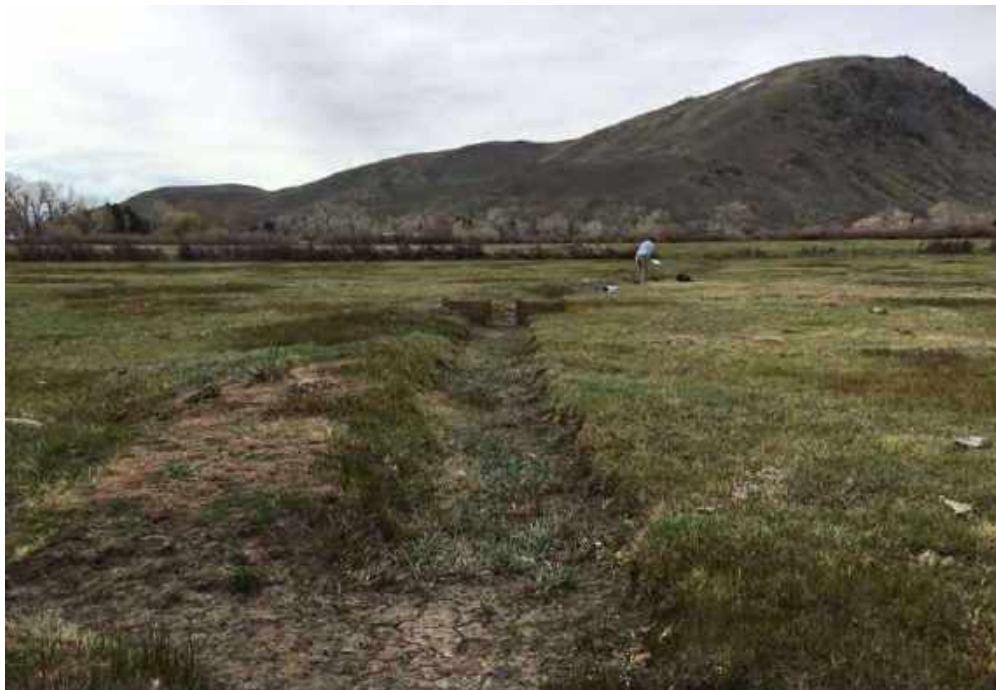
Photo 12. AR-4a: Southern end of AR-4 excavated irrigation ditch. Old irrigation ditch capturing sheet flow across pasture. Small weir visible in picture no longer operating. View looking south.

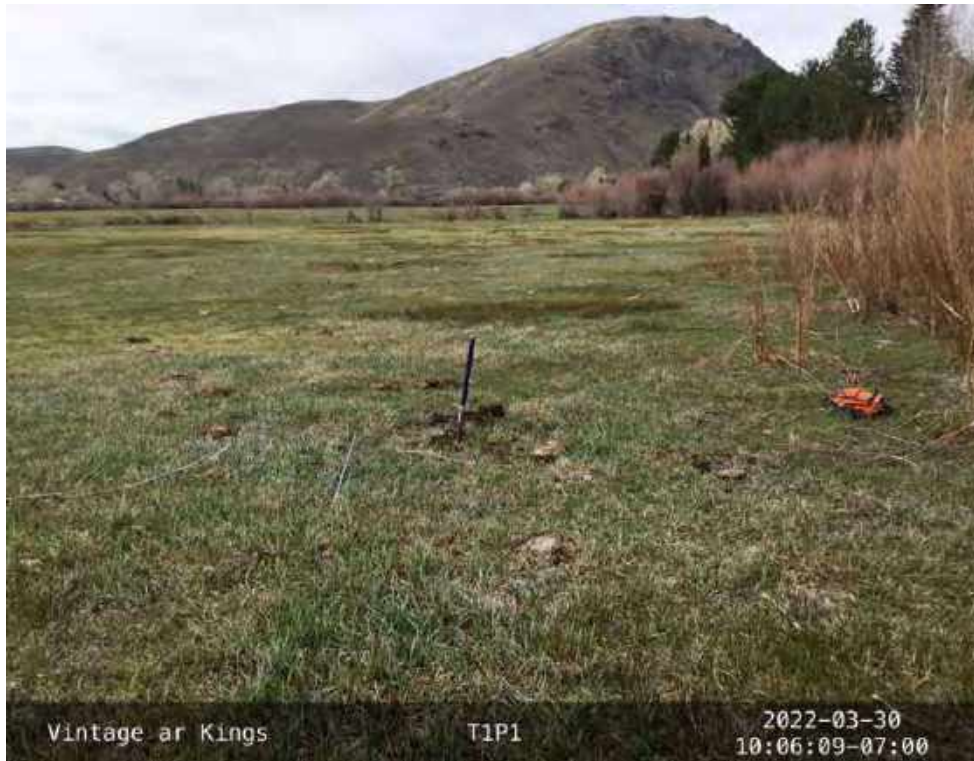
Photo 13. T1-P1: Data point taken at western boundary of Survey Area adjacent to willow stand surrounding AR-2 irrigation ditch. Vegetation was dominated by an unknown sedge species (*Carex* sp., OBL-FAC) and Narrow-leaf willow (*Salix exigua*, FACW). View looking south.

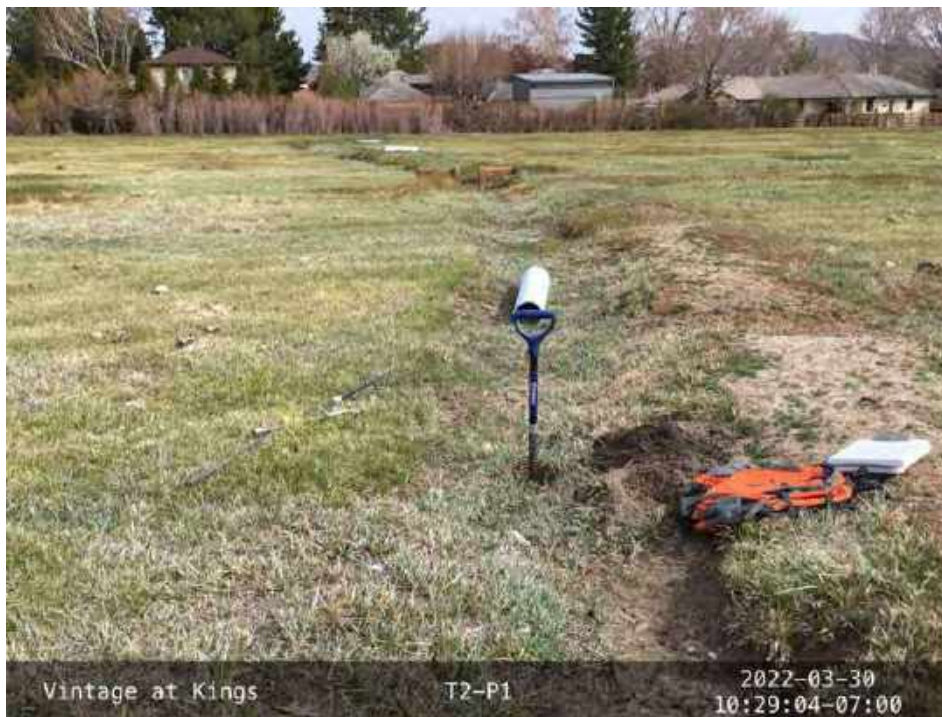
Photo 14. OHWM- 5: T2-P1 collected just north of OHWM-5 in swale area. Vegetation dominated by an unknown sedge species (*Carex* sp., OBL-FAC). View looking north.

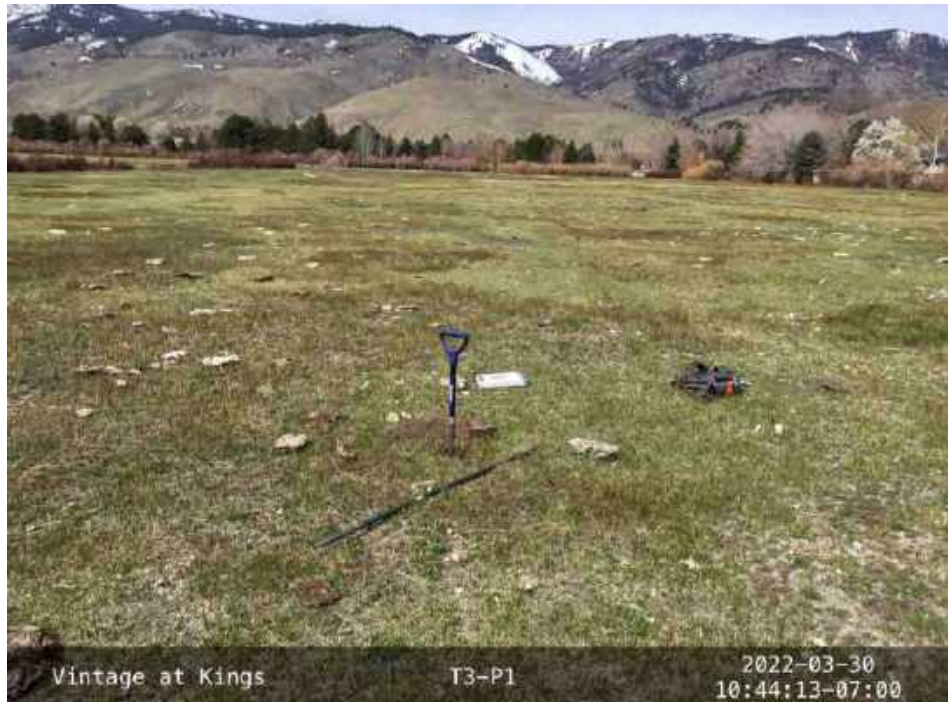
Photo 15. T3-P1: Data point taken in northeast upland portion of Survey Area. Vegetation was dominated by Cheatgrass (*Bromus tectorum*, UPL), Western tansymustard (*Descurainia pinnata*, UPL), and Common stork's-bill (*Erodium cicutarium*, UPL). View looking west.

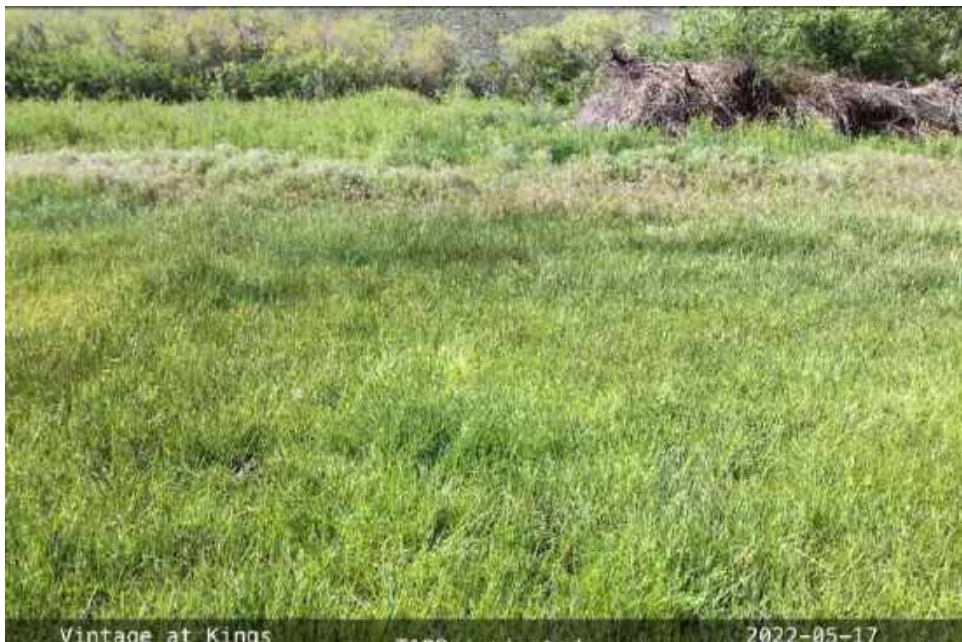
Photo 16. T1-P2: Data point taken at low point in western boundary of Survey Area adjacent to AR-1. Photo collected later (5/17/2022), showing more growth. Vegetation dominated by Kentucky bluegrass (*Poa pratensis*, FAC), Graceful cinquefoil (*Potentilla gracilis*, FAC), and Douglas' sedge (*Carex douglasii*, FAC). No hydric soils of wetland hydrology in the absence of irrigation.

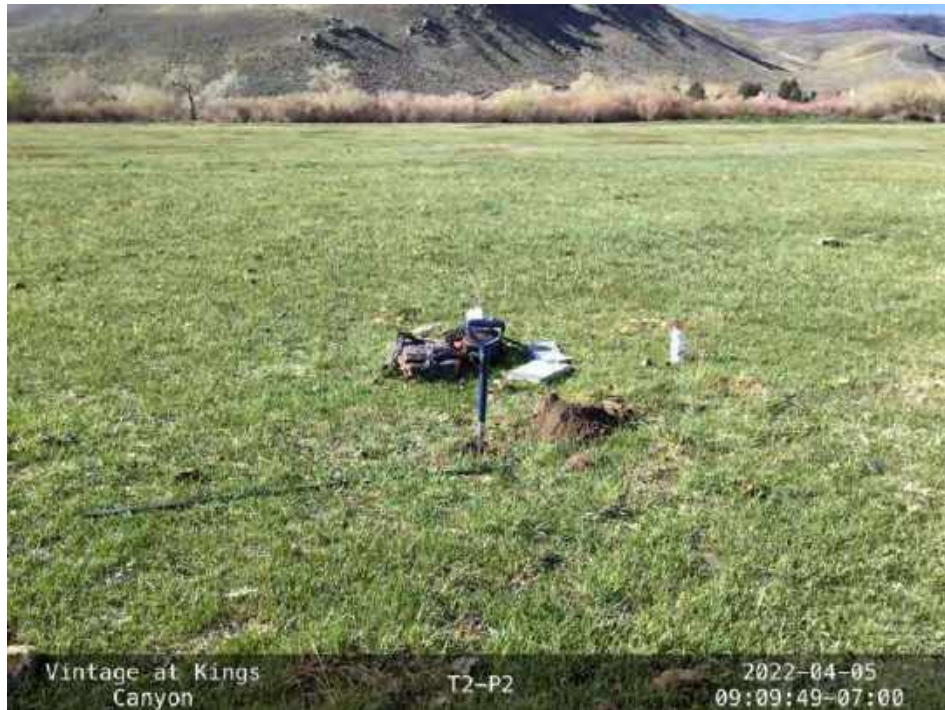
Photo 17. T2-P2: Data point taken in irrigated pasture (typical) north of AR-1 and west of AR-4a. Vegetation was dominated by White Clover (*Trifolium repens*, FACU), Baltic rush (*Juncus balticus*, FACW), and an unknown sedge (*Carex* sp., OBL-FAC). No hydric soils of wetland hydrology in the absence of irrigation.

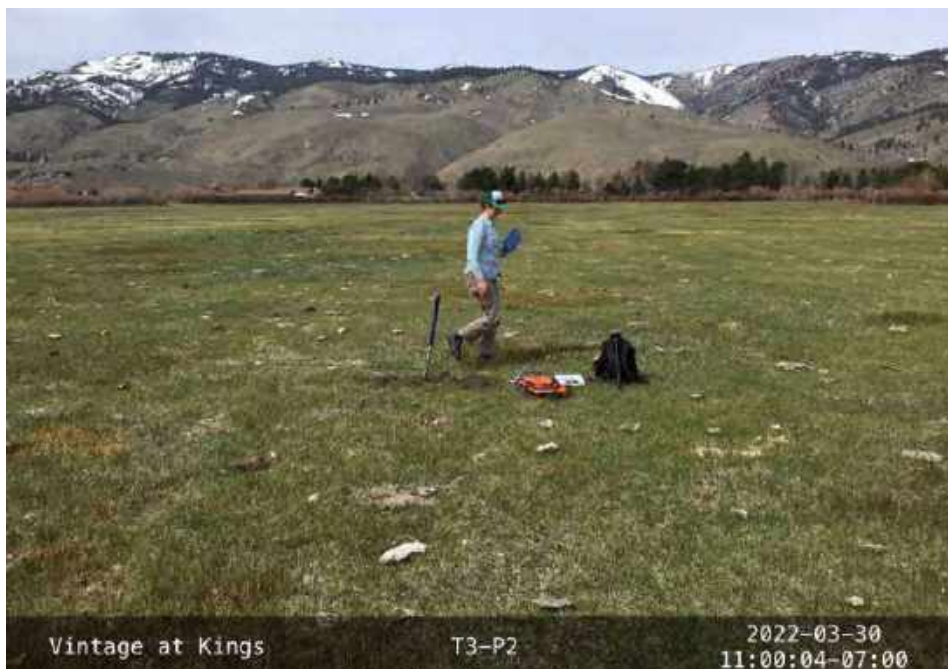
Photo 18. T3-P2: Data point taken in east end of irrigated pasture north of Ash Canyon Creek (AR-2). Vegetation was dominated by an unknown sedge (*Carex* sp., OBL-FAC), Douglas' sedge (*Carex douglasii*, FAC), and Common stork's-bill (*Erodium cicutarium*, UPL).

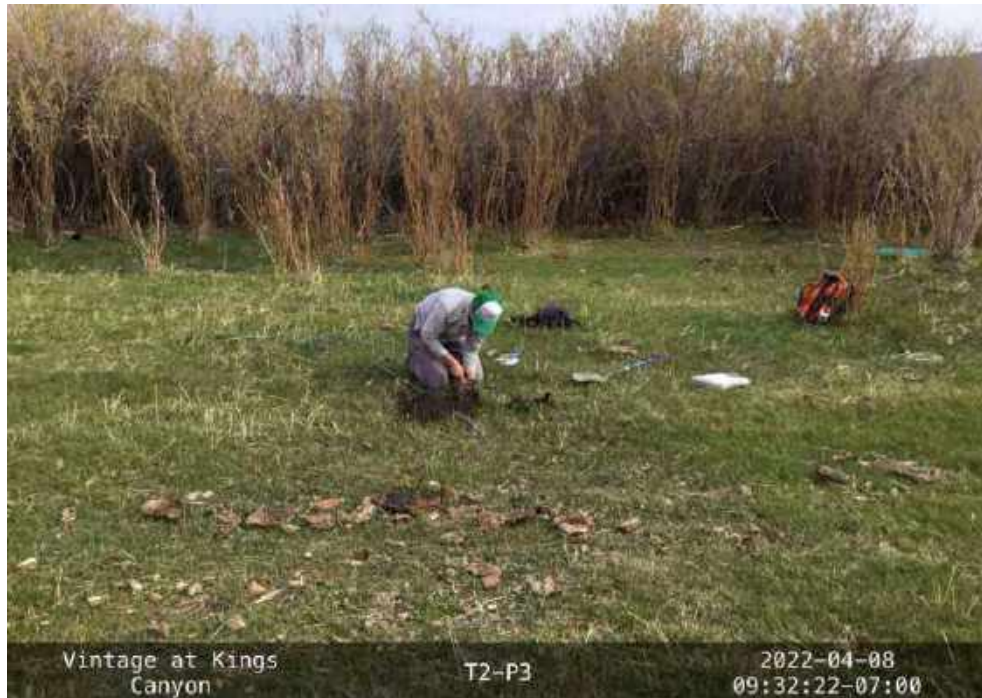
Photo 19. T2-P3: Data point taken in low spot adjacent to Ash Canyon Creek (AR-1). Vegetation dominated by Kentucky bluegrass (*Poa pratensis*, FAC), Douglas' sedge (*Carex douglasii*, FAC), and Baltic rush (*Juncus balticus*, FACW). No hydric soils of wetland hydrology in the absence of irrigation.

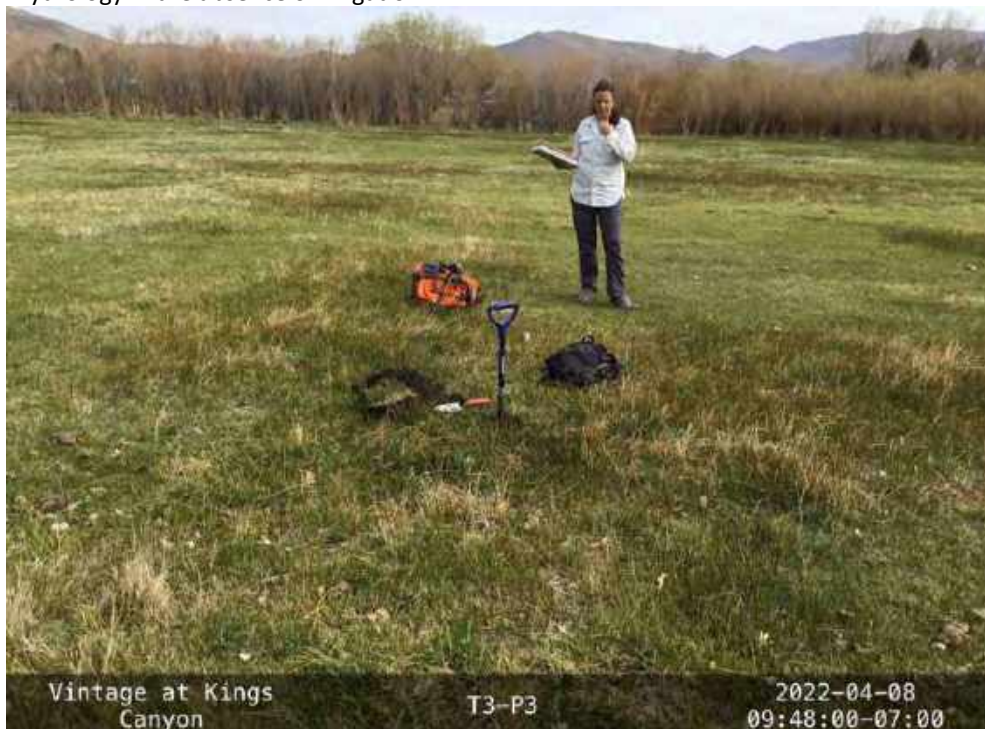
Photo 20. T3-P3: Data point taken in low spot within irrigated pasture. Vegetation dominated by Douglas' sedge (*Carex douglasii*, FAC) and Baltic rush (*Juncus balticus*, FACW). No hydric soils of wetland hydrology in the absence of irrigation.

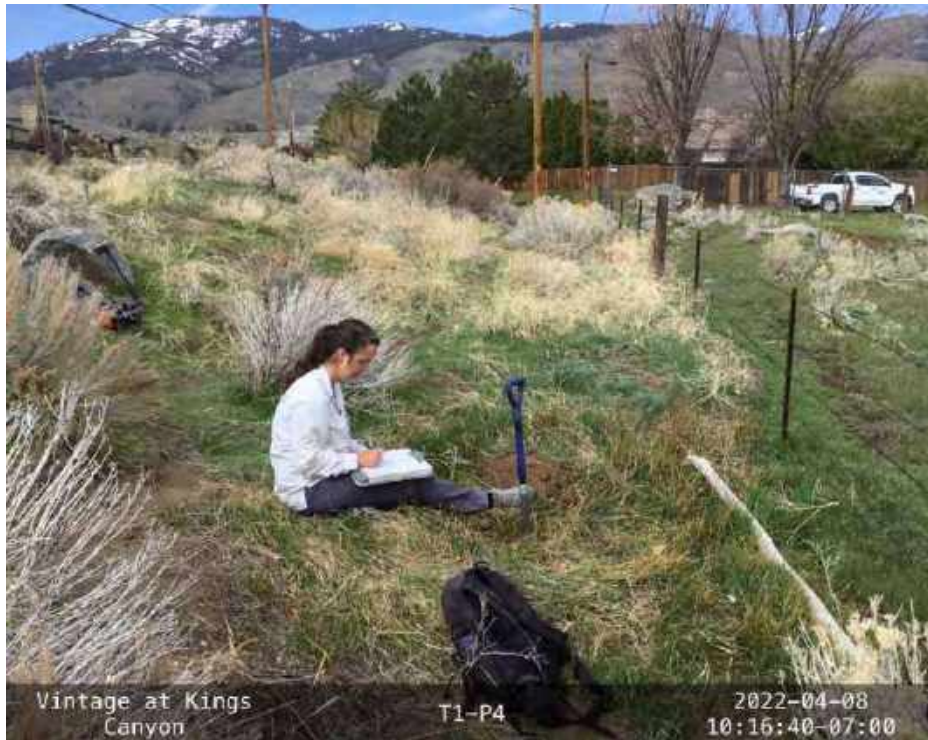
Photo 21. T1-P4: Data point taken in upland irrigated pasture. Vegetation is dominated by Big sagebrush (*Artemesia tridentata*, UPL), Cheatgrass (*Bromus tectorum*, UPL), and Fiddleneck (*Amsinckia tessellata*, UPL). View looking west.

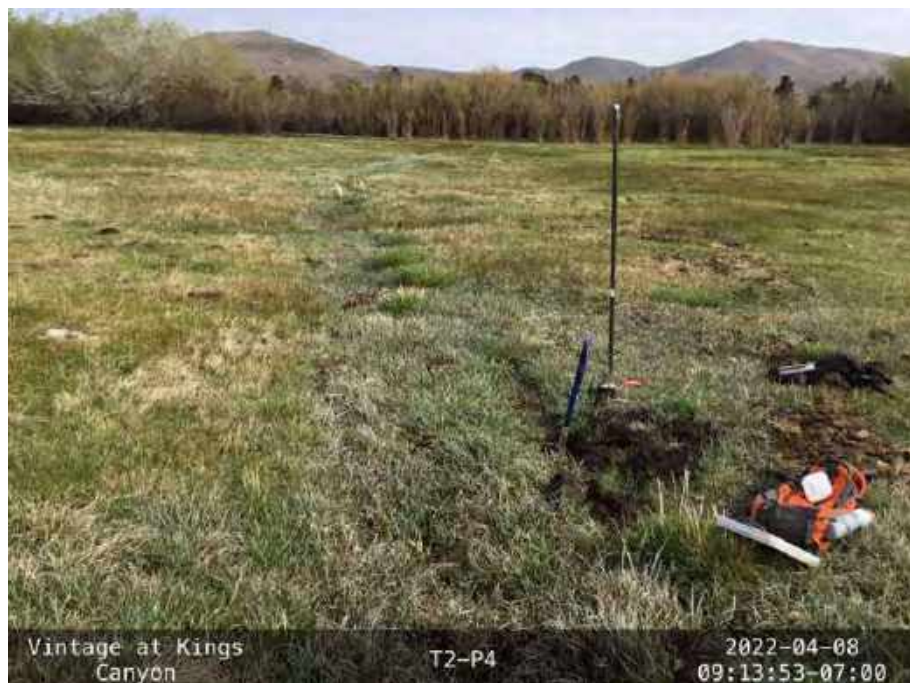
Photo 22. T2-P4: Data point taken within low point of pasture, likely a remnant of an irrigation ditch. Vegetation dominated by Kentucky blue grass (*Poa pratensis*, FAC), Douglas' sedge (*Carex douglasii*, FAC), and an unknown sedge species (*Carex* sp., OBL-FAC).

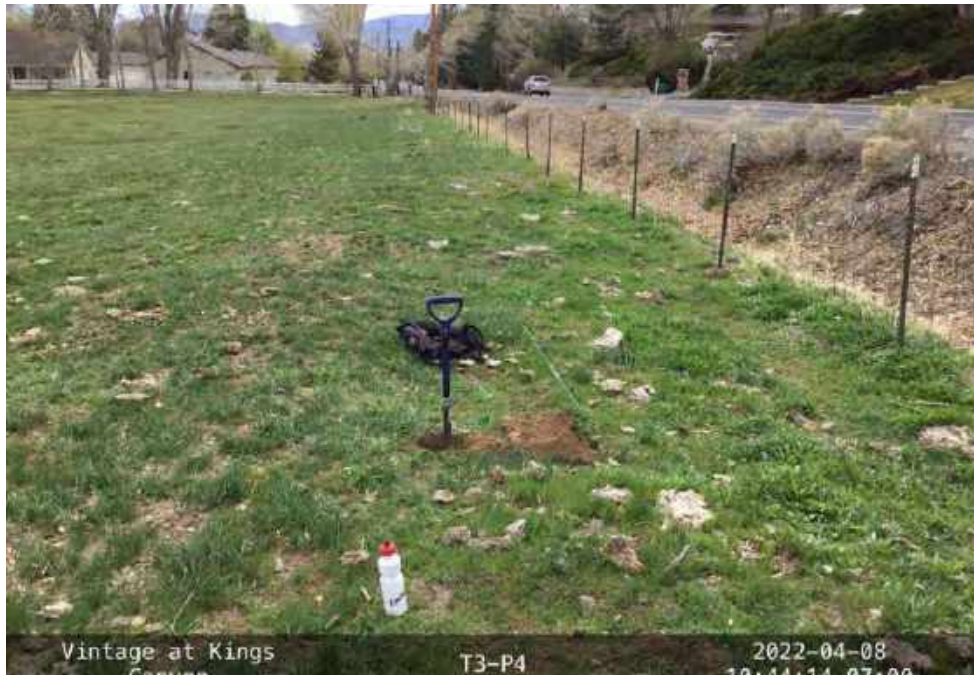
Photo 23. T3-P4: Data point taken on a slight rise in southern part of pasture. Vegetation is dominated by Kentucky Bluegrass (*Poa pratensis*, FAC) and Douglas' sedge (*Carex douglasii*, FAC).

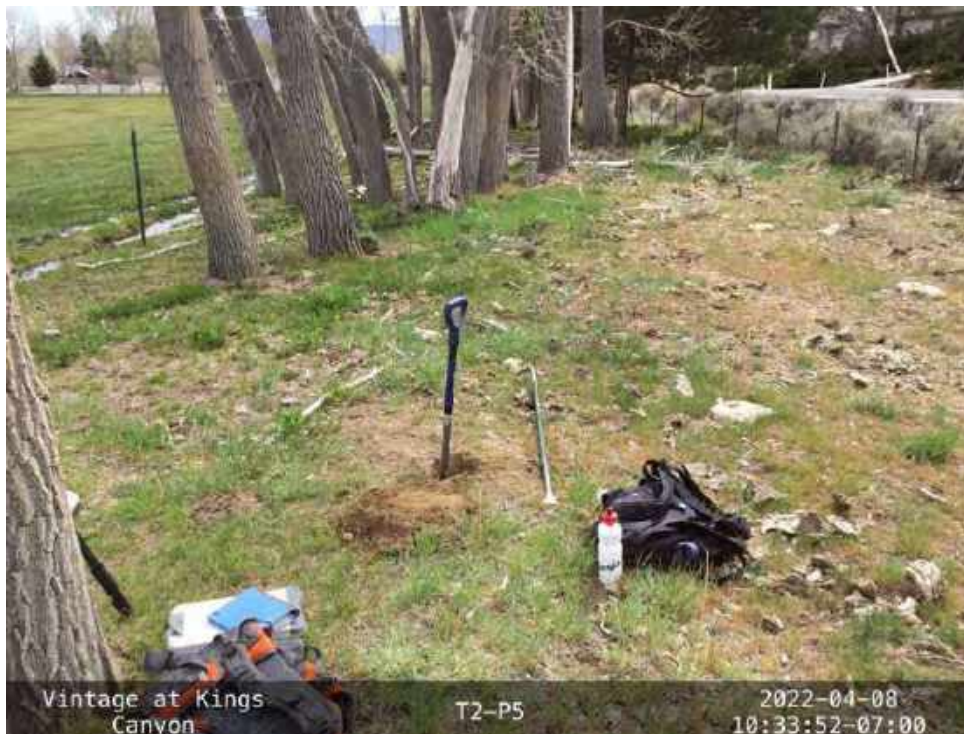
Photo 24. T2-P5: Data point collected in upland at southern end of Survey Area. Vegetation is dominated by Fremont Cottonwood (*Populus fremontii*, UPL), Big Sagebrush (*Artemisia tridentata*, UPL), Kentucky blue grass (*Poa pratensis*, FAC), and Common Stork's-bill (*Erodium cicutarium*, UPL).

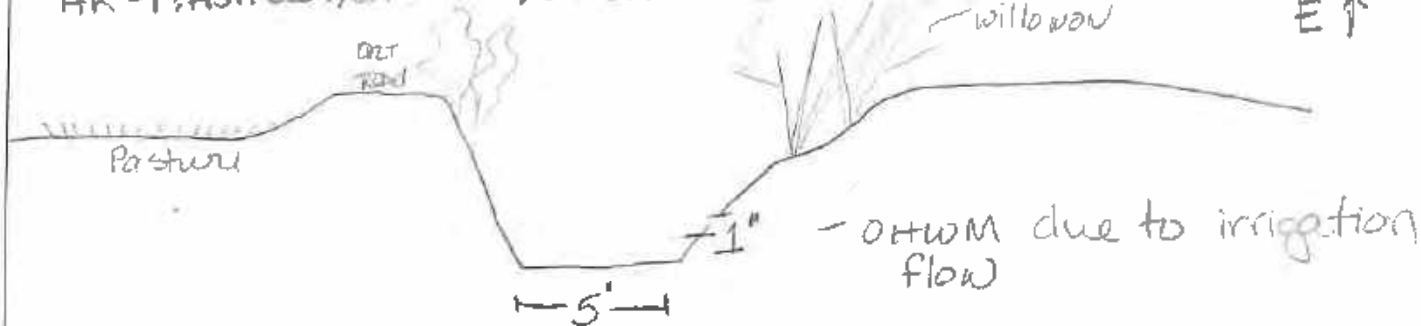
AR-1: Ash Canyon Creek / Ditch

Transect (cross-section) drawing: (choose a location that is representative of the dominant stream characteristics over some distance; label the OHWM and other features of interest along the transect) include an estimate of transect length)

The on-site length of AR-1 is 1,510 linear feet (0.17 acres), with an average width of five feet at OHWM-1. The OHWM was identified in the field by a lack of terrestrial vegetation and a change in substrate. There was approximately four inches of standing water within the ditch at the time of the delineation. AR-1 is described in OHWM-1 data form located in Attachment F and identified in photos 4 and 5 shown in Attachment C.
